## KINGS COVERED BRIDGE REHABILITATION SOMERSET COUNTY, PENNSYLVANIA

### Summary

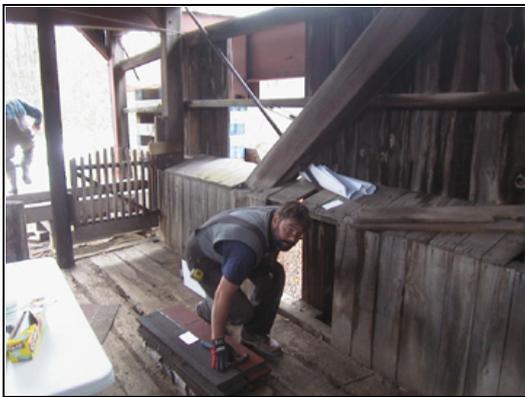
*Fig. 2 Human and livestock gates at east portal. Note the diagonal repair rods through the truss braces, which were installed early in the twentieth*

Project engineers agree that it was the King Family who was responsible for ensuring the bridge’s survival by maintaining the roof and installing a remarkably astute homespun system of tension rods when both lower chords began to fail. During the rehabilitation, these rods were un-tensioned and ultimately left in place to acknowledge the family’s interventions and to interpret the full structural history of the bridge, in keeping with the project preservation plan.

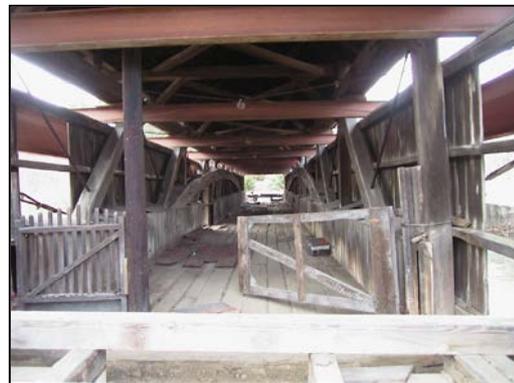
*Fig 3: Same gates from outside.*

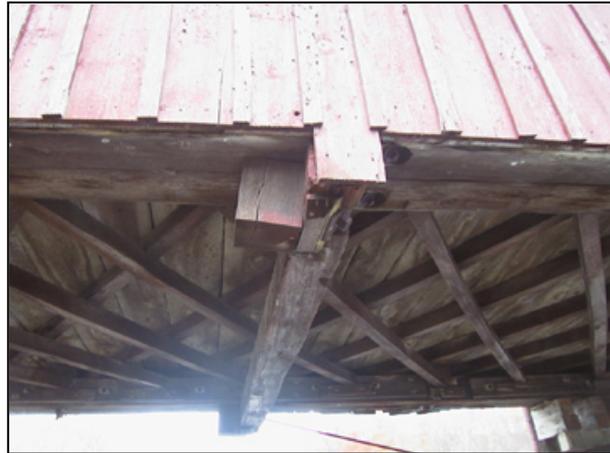
**2.5 Joists / Floor;** A rare, lattice system of floor joists was used below the timber deck, where one layer of diagonal joists was overlaid by a second layer at an opposite angle. These light, circular sawn 5 x 6s were bearing on two levels of individual ledger blocks nailed to the inside face of the lower chords. Overlapping joists were not fastened at their intersections like lattice trusses. The longer joist spans created by this design appear to have combined the purposes of transverse beams, longitudinal stringer beams, and under floor diagonal bracing into one system that carried floor loads and provided lateral bracing. The lower layer of decking was laid transverse, while the upper was laid longitudinally.

*Fig. 4: Lattice floor joist system and lower tie beam added after original construction.*

**Restore other members and sheathing materials:** The members of the lattice joist floor system were replaced in-kind. Some of the decking was reused as subflooring, but most of the remainder was replaced by rough-sawn hemlock boards. Both courses were laid transverse with staggered joints. Some rafters and all lath were replaced in-kind.

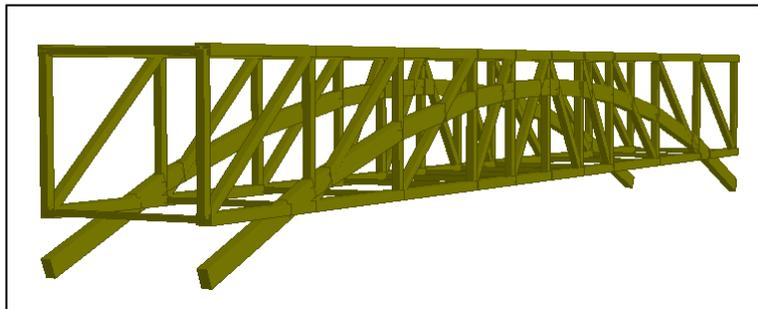
**Figure 5:** 3-D Rendering (STAAD Model) of Kings Bridge

In this analysis, a combination of dead, live, wind, and snow loads was followed. The load combination used was in accordance with ANSI/ASCE 7, Minimum Design Loads for Buildings and Other Structures (Section 2.4),  $Dead + (Wind + Live + Snow) \cdot 0.75$ , which is considered conservative for analysing extant covered bridges (according to the Federal Highway Administration's *Covered Bridge Manual*). A three dimensional (3-D) space frame model of the bridge was developed using STAAD with the loads applied at the top and bottom panel joints as per the ANSI/ASCE 7 load combinations. The versatility of the 3-D model made possible the addition of the top X-bracing members and their analysis for the lateral loads. The 3-D model also made possible a very realistic representation of the actual structure. The continuity of the top and bottom chords and the arches was preserved, although the bottom chord was severely damaged (i.e., ruptured) at two locations that were not modeled.

The results from the STAAD analysis containing member forces, moments, and joint deflections were analysed with two objectives in mind: (1) to compare the computed stresses with allowable stresses (obtained from the National Design Specification (NDS) for wood construction) to ascertain the degree of safety of the member in question; and (2) to achieve some understanding of how the arch-truss system behaves, i.e., stress distribution and deflections. From the analysis it was determined that the most important structural characteristic of the arch-truss system of the Kings Covered Bridge when compared to the original multiple kingpost system was the stiffness associated with deflections. The addition of the Burr arch greatly reduced the deflection by a factor of approximately three under full load, suggesting the synergy of both the arch and truss producing a structure that is stiffer than the kingpost truss acting alone. For long span timber bridges, such as Kings Bridge, the arch provides a necessary stiffening of the truss so that deflections resulting from live and dead loads are controlled to acceptable limits. The addition of the arch also accomplished a reduction of member stresses and even the critical lower chord-arch joint member was satisfactory.

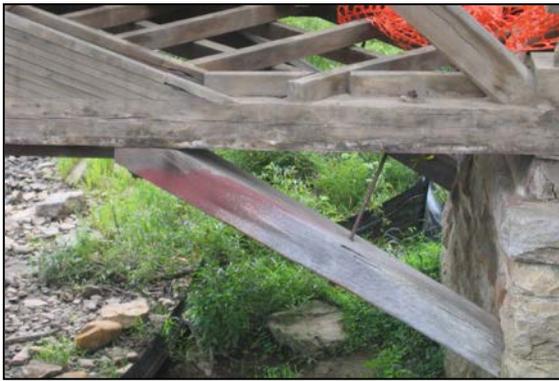
**3.3 Arches / Struts:** The arches were visibly deformed above the locations of lower chord failures, exhibiting the transfer of loads from the adjacent truss posts through the arch and back into the trusses and lower chords to the foundations. Struts were installed below the lower chords and were never sheathed by the bridge siding. The hearts of these untreated heavy timbers decayed at the bearing seats and remained in place suspended by metal tie rods only

*Fig. 6: Arch "tied" to chord and strut below to abutment.*

**4.1 Extend arches:** The arches were extended below the lower chords by adding in-kind laminations to the existing nail-laminated arches. The cross-section area of the arch was removed from the corresponding section of each lower chord member to allow the new arch extension to bypass the chord unfastened.

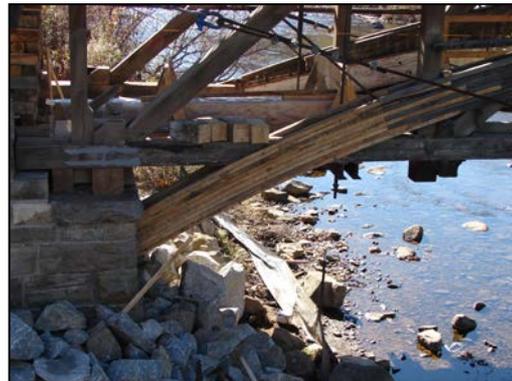
*Fig 7: Laminated arch extended to reinforced abutment.*

While the bridge was elevated for rehabilitation, the new arch extensions were installed and scribed to meet the new seats carved in the stone abutments before the bridge was lowered into place. The ends of the timbers were treated with wood preservative and elastomeric pads were used as compressive and thermal insulators between the stone and wood at the bearings. The new arch extensions were intended to remedy the damage to the trusses caused by the previous tied arch geometry. The deformed arch sections were separated, reshaped, and re-laminated in place. Repairs were also made by extending the laminations past the lower chords by dapping (notching) a portion of the bottom chord members. The new laminations follow the existing butt joint pattern and are also nail-laminated, stitched, and joined with epoxy. This repair includes the addition of a GFRP flitch plate with epoxy applied to both sides of the GFRP plate to reinforce the notched bottom chord.

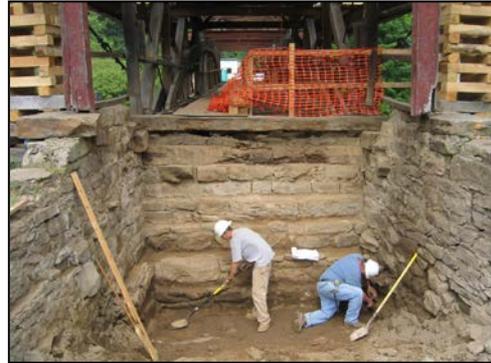
*Fig 8: Excavated abutment before reinforcement.*

**4.2 Rebuild / reinforce stone abutments:** A system of abutment reinforcements was designed to buttress the existing stone abutments. The abutment / wingwalls were completely excavated and

formed to receive flowable backfill to create the buttress that would withstand the new forces created by the extended arches. An estimated 20 percent of the substructure stone was removed and re-laid in the rehabilitation process. All former Portland cement grouting was removed, and all joints were re-struck with a softer mix using a greater percentage of lime to avoid spalling at the edges of the softer stone with the harder mortar. New white oak sills were installed to replace the previous sills that had deformed under the horizontal loads imparted after the chord breaches.

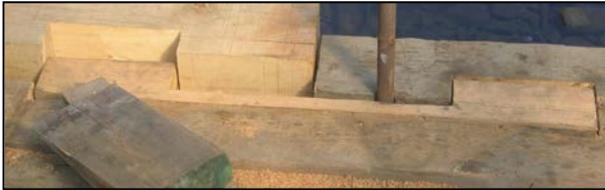
*Fig.9: Joggle splice repair (above).*

**Replace posts, braces and chords (full and partial):** Based on visual inspection, the non-destructive testing conducted by FPL, and the results of the structural analysis, several repair types were implemented. Glass Fiber Reinforced Polymer (GFRP) reinforcing rods embedded in epoxy were used to repair existing timber members where deterioration was such that an epoxy mortar repair was not appropriate, where a new section of wood was to be added to an existing original member, or where a fractured original member was restored. Another repair type intended to repair an existing fractured or missing timber section required the installation of a new white oak implant “joggle” at the splice location. This repair method represents a traditional timber joinery splice consistent with that period.

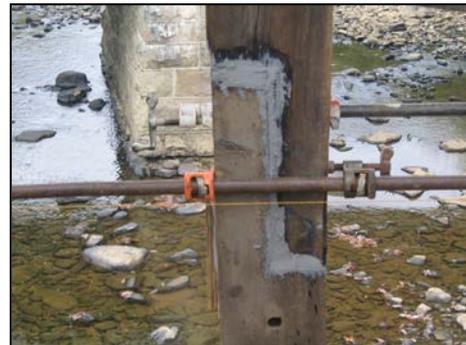
**3.2 Truss Posts:** Roof leaks above the lower chord failures also resulted in damage to joints and several truss posts and shouldered truss braces in Kings Bridge. The heads of two posts failed in shear at the joints due to excessive new loading patterns resulting from the lower chord failures. Several of the posts were found to be only partially damaged, while one required total replacement.

*Fig. 10: GFRP post repair (opposite).*

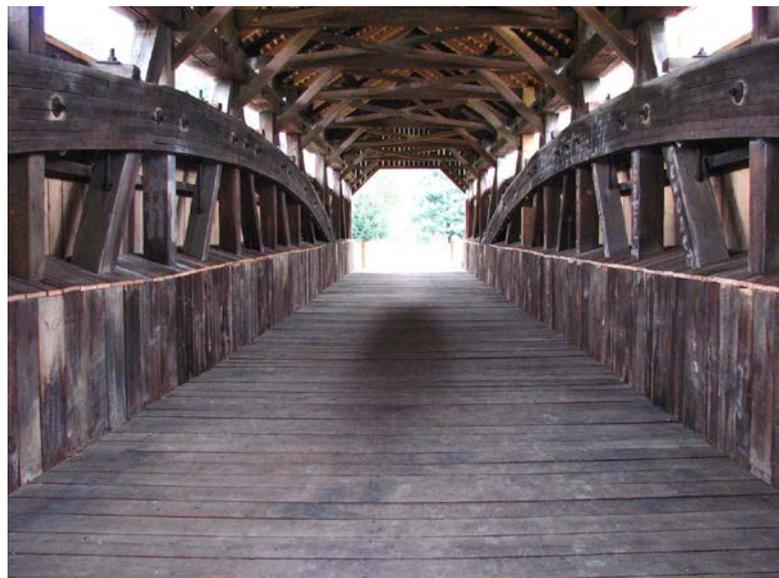
*Figure 11: Interior rehabilitated.*

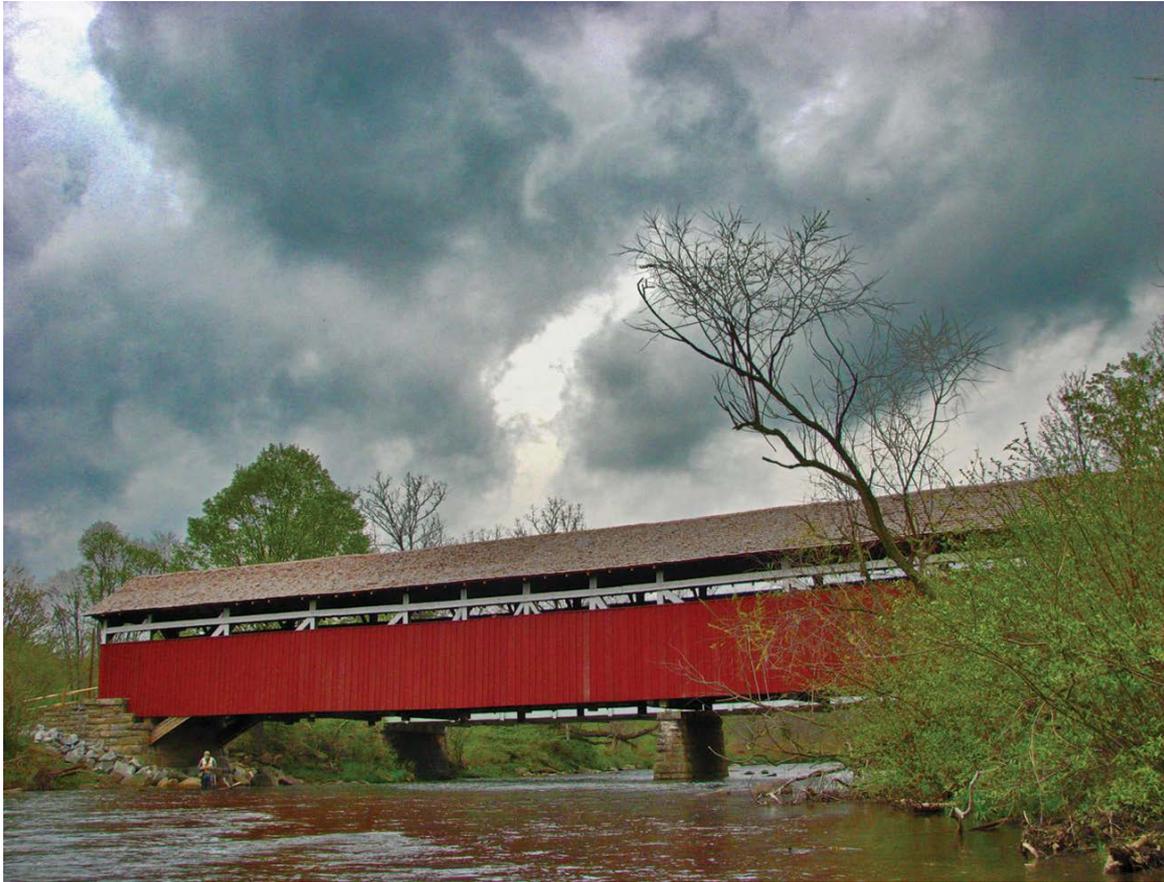
*Figure 12: South elevation – rehabilitated.*

Rough-hewn cedar shingles were installed to the lath. Most of the siding was replaced in-kind, with some reused as battens. The wainscoting and cap material was stockpiled and then reinstalled.
