## Goodpasture Covered Bridge Rehabilitation

The Goodpasture Covered Bridge, crossing the McKenzie River, is a 72.5 m (238-foot) five-span timber structure that provides lifeline access to a large community. The main span is a 50.3 m (165-foot) covered heavy timber Howe truss. The truss chords have three leaves, each made of segments spliced together. Eight of the sixteen bottom chord splices were broken, and the truss sagged 100 mm at mid-span. Site constraints dictated that all repair work be performed under traffic and without temporary support beneath the bridge. The solution was a post-tensioning system for the bottom chords to provide an alternate load path. To lift the center of the bridge to the proper camber without support from below, a pair of tube-steel trusses were constructed inside the house to bear the loads. The bridge was lifted 200 mm at mid-span to achieve 100 mm of positive camber, and held by the steel trusses while the hanger rods were tightened and post-tensioning system installed.

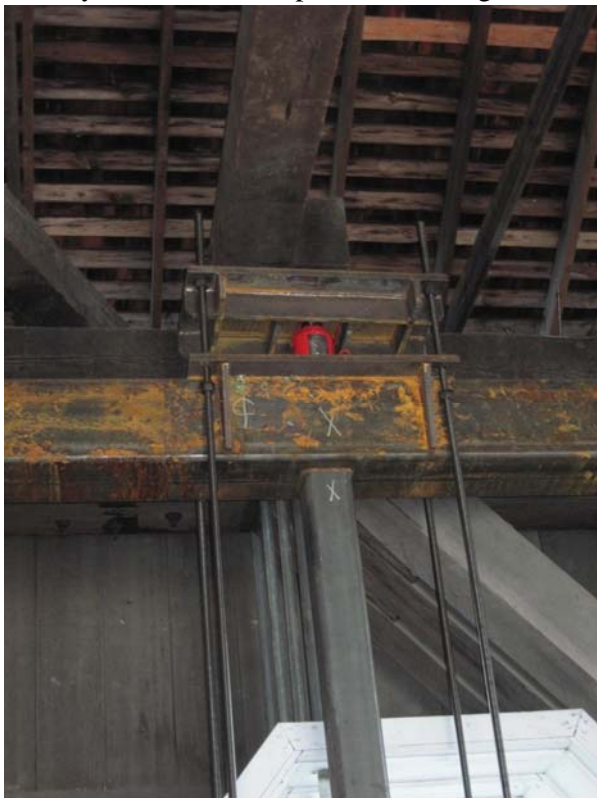
Fig. 3 Jack on temporary steel truss

Each steel truss was manufactured in three pieces and assembled inside the timber bridge. Then a series of lifting platforms was installed below the floor beams of the timber bridge suspended by steel rods from hydraulic jacks placed on the steel trusses. The timber bridge was lifted 200 mm at mid-span to achieve 100 mm of positive camber. While held in the correct shape by the steel trusses, the vertical hanger rods of the timber bridge were tightened, and the post-tensioning system consisting of six 13 mm-diameter Grade 1200 strands on each side of each bottom chord was installed. Each strand was jacked to 89 kN, yielding a total compressive force of 1068 kN on each bottom chord. This reduces tensile stresses in the bottom chords enough to enable the covered bridge to safely carry legal loads. Then the tube steel trusses were disassembled and removed.

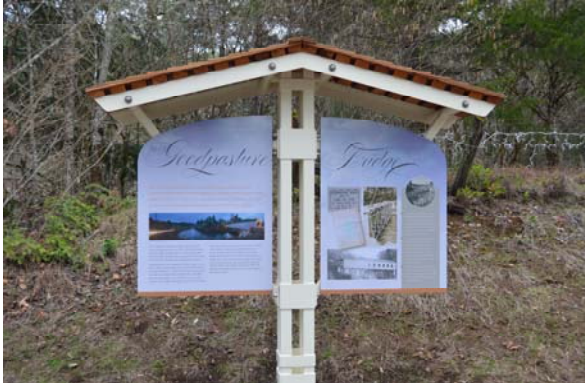
*Fig. 4 Interpretive display*

To complete the project, bridge lighting was installed, and an interpretive display devoted to the history of the bridge was added at the top of an existing stairway leading to the river bank at the southeast corner of the bridge.

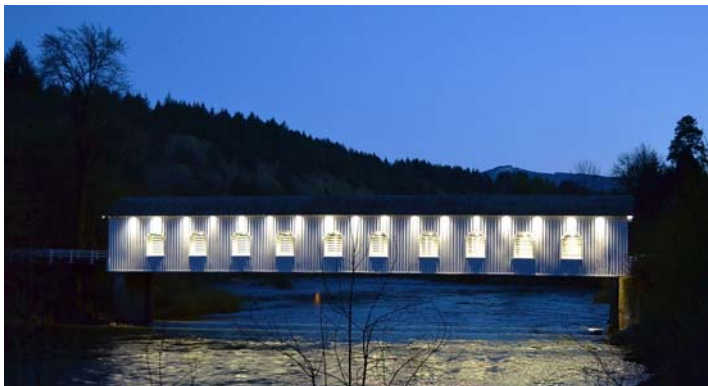
*Fig. 5 LED lighting on bridge*

High-efficiency LED lights were installed in the windows, under the eaves and behind the barge rafters at the portal ends, activated by an external light sensor and discretely illuminating the ends and side walls from concealed fixtures.
