# Chambers Covered Railroad Bridge Salvage and Rehabilitation

## Summary

The Chambers Covered Bridge was built in 1925 and is the last remaining covered railroad bridge in Oregon, possibly the only one west of the Mississippi. Therefore, its rehabilitation was critical to historic preservation efforts of the country's remaining covered rail bridges. Before rehabilitation, the 27.4 m (90-foot) long timber structure was in danger of collapse after decades of neglect. In 2010 a windstorm threatened to destroy the bridge. This unique, single-span, four-leaf Howe truss structure was dismantled and rebuilt using almost all the original iron and hardware, and 25 percent of the original timber. The bridge was reconstructed on dry ground and launched onto the existing concrete piers. The rehabilitated Chambers Covered Bridge now serves as a landmark pedestrian and bicycle crossing that provides safe access across the Coast Fork of the Willamette River. Locomotive-inspired artwork within and around the structure evoke the bridge's history.

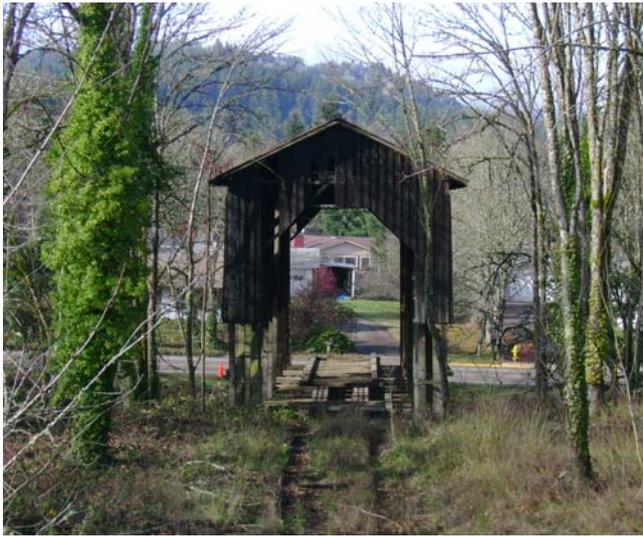
*Fig. 4 Chambers Bridge before rehabilitation*

For over sixty years the bridge was neglected and attracted vandalism. Most of the siding was kicked off, and local youths would jump from the trusses into the river. Twice fires were built in the abandoned structure, but luckily it did not fall. Large sections of roofing were missing, so the structure was no longer protected from weather. The 2006 inspection revealed that at one location near mid-span of the bottom chord, the combination of decay and vandalism left only 7 percent of the original material intact. It is a testament to the original robustness of the structure that it continued to stand after such aggressive deterioration.

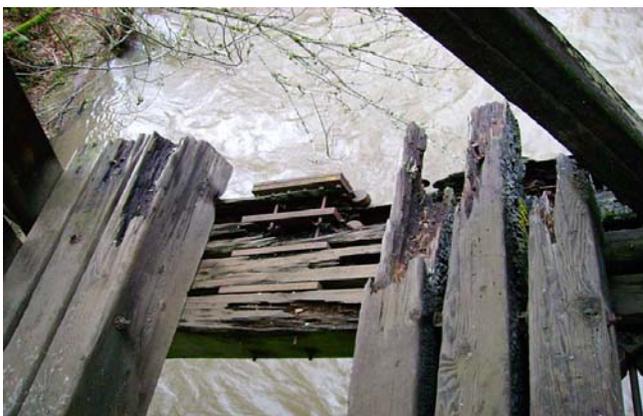
*Fig.5 Bridge deterioration*

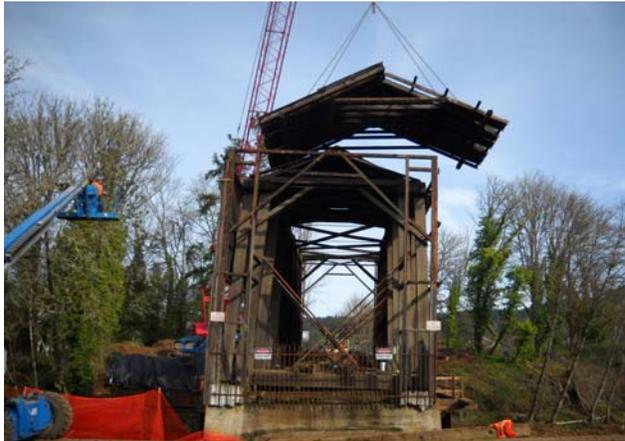
*Fig. 6 Bridge being dismantled*

Removal of the existing bridge was an emergency that could not wait for the next in-water work period. Furthermore, the bridge spans the Coast Fork of the Willamette River, an environmentally sensitive stream that is very popular with boaters and anglers. Therefore, no supports could be placed in the active channel during removal. The design involved construction of steel tracks attached to the existing piers and a rolling platform that spanned the river. The platform was built adjacent to the bridge then rolled under it, where it was anchored in place and used to stabilize the existing structure and to provide a work surface. Removal was very systematic, and complex hardware assemblies were kept together and in sequence to facilitate future reassembly.

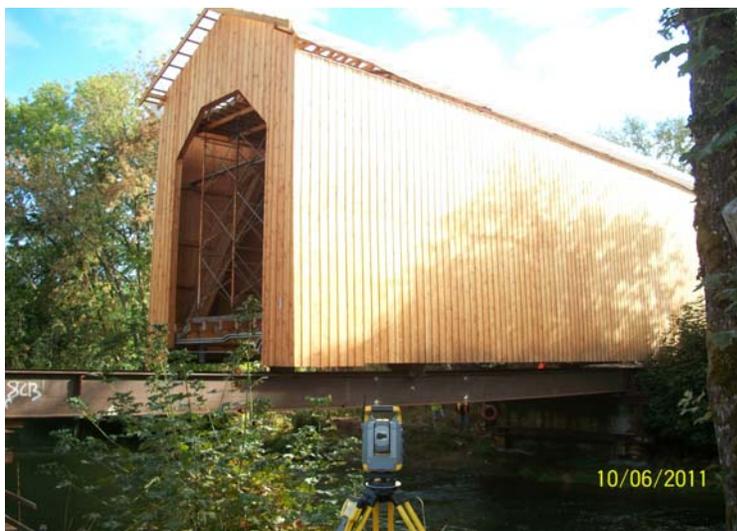
*Fig. 7 Rehabilitated bridge being moved into position*

Almost all of the original hardware, including the hanger rods with upset threads, was cleaned by shot-blasting, then painted and reinstalled. Unfortunately, the hanger rod nuts had to be cut off; however, the machine shop in Cottage Grove that had fabricated the original nuts is still in business, and they were able to make replacements identical to the originals. Though most of the timber was in an advanced state of decay, a portable sawmill was set up on site, and all members that contained sound wood were resawn into smaller but usable sizes. Approximately 25 percent of the wood in the rehabilitated bridge was cut from old bridge timbers.

The skylight is not visible from outside the covered bridge but washes the interior with natural light. Before rehabilitation began, a set of steel tracks was erected spanning the river from the east bank to the west pier on deep wide-flange beams. The bridge was erected on these tracks over dry land and rolled into position after completion, then lifted with hydraulic jacks and lowered onto the piers. Finally, the tracks and steel beams were removed, and the approach spans completed. A video of the launching can be found at <http://www.obec.com/bridge/chambers-covered-bridge.html>.
