Field Performance of Timber Bridges: A National Study

Brian K. Brashaw
Program Director
University of Minnesota
Duluth, Natural Resources
Research Institute
Duluth, MN, USA
bbrashaw@nrri.umn.edu

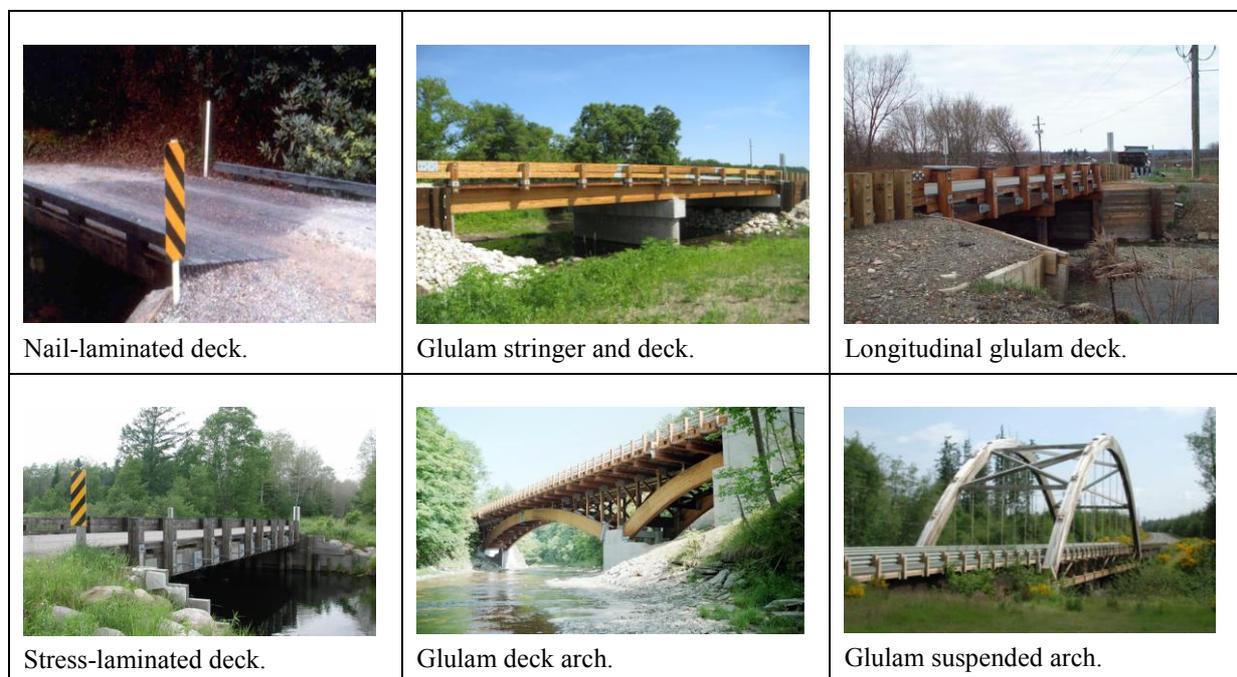
Figure 2 – Photographic examples of various timber bridge superstructures.

There are a variety of timber bridge superstructure types. The main categories are longitudinal decks, stringer systems, and others. Longitudinal decks include nail-laminated, spike-laminated, stress-laminated (using either sawn lumber or glulam laminations), and longitudinal glulam bridges. The spike-laminated and longitudinal glulam deck superstructures consist of partial width panels that are interconnected with transverse stiffener beams attached at intervals along the bridge length. Stringer systems include sawn lumber, glulam, steel, and fiber-reinforced polymer (FRP) glulams. Other timber bridge superstructures include arches, trusses, and cable-supported structures. Photographic examples of several timber bridge superstructure types are provided in Figure 2.

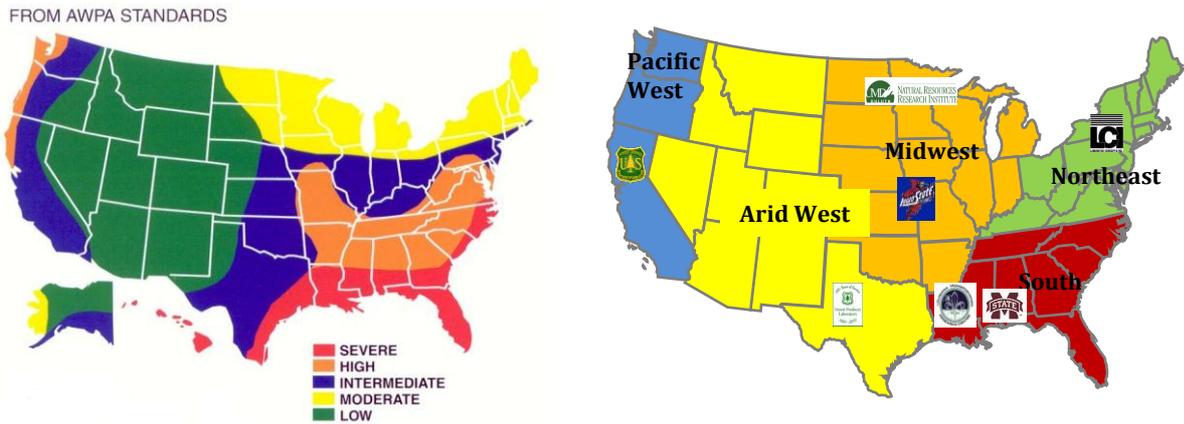
Figure 3 – Wood decay hazard map and team inspection assignments in the continental U.S.

selected for bridge inspection were based on the American Wood Protection Association (AWPA) wood decay hazard map shown in Figure 3. In order to assess these regions, a diverse project team was created that included: Tom Williamson Timber Engineering LLC, Rogue River-Siskiyou National Forest, Iowa State University, University of Minnesota Duluth, Mississippi State University, Louisiana Transportation Research Center, and Laminated Concepts Inc. Each organization represented a U.S. region and would be responsible for inspecting bridges in their respective regions. Figure 3 also shows the general geographic region for each organization.

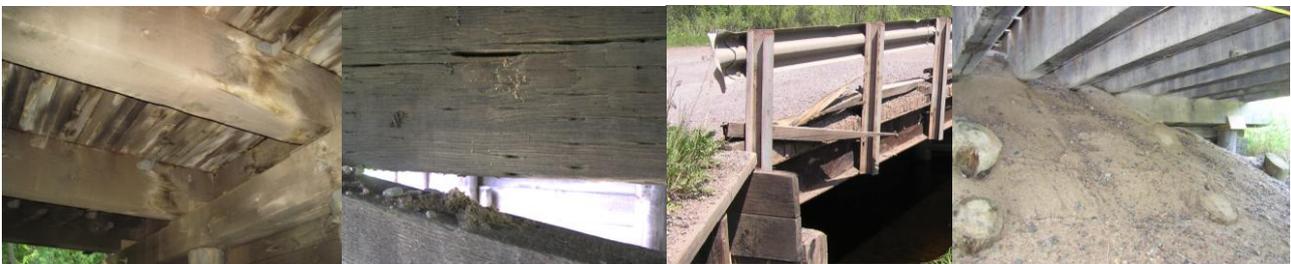
Figure 4 – Visual inspection conditions including discoloration and staining, insect activity, mechanical damage and build-up of sand and gravel.

investigation. Visual inspection should never be the sole method used. Visual inspection requires strong light and is useful for detecting intermediate or advanced surface decay, water damage, mechanical damage, or failed members. Visual inspection cannot detect early stage decay, when remedial treatment is most effective. During an inspection, the following signs of deterioration should be investigated: fruiting bodies, sunken faces or localized collapse, staining or discoloration, insect or animal activity, plant or moss growth, checks and splits, weathering or impact damage, or rotation of members. Figure 4 shows several visual indicators evident during bridge inspection.

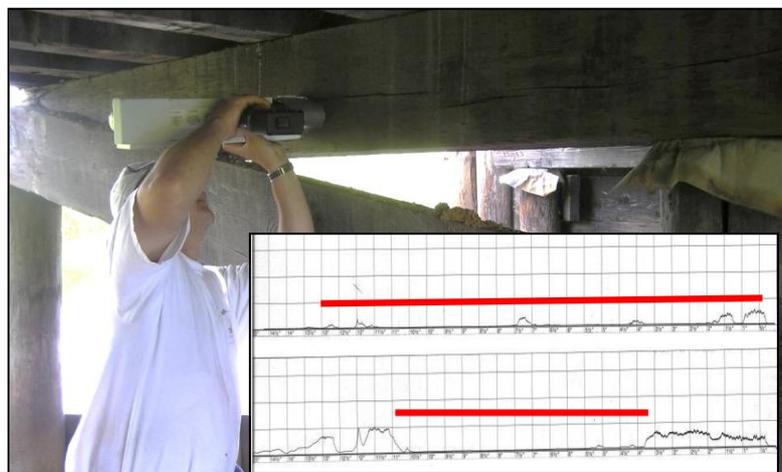
The resistance drill system measures the resistance of wood members to a 1.5-mm drill bit with a 3.0-mm head that passes through them. The drill

Figure 5 – Resistance microdrilling techniques were used to inspect timber bridge elements.

bit is fed at a fixed movement rate allowing the inspector to determine the exact location and extent of the damaged area. This system produces a chart showing the relative resistance over its travel path. This chart can be produced either as a direct printout or can be downloaded to a computer. Areas of sound wood have varying levels of resistance depending on the density of the species and voids show no resistance. The inspector can determine areas of low, mild, and high levels of decay. Figure 5 shows a timber abutment cap being assessed with a resistance microdrill and the resulting chart image showing minimal drilling resistance that indicating that the majority of the cap is decayed.

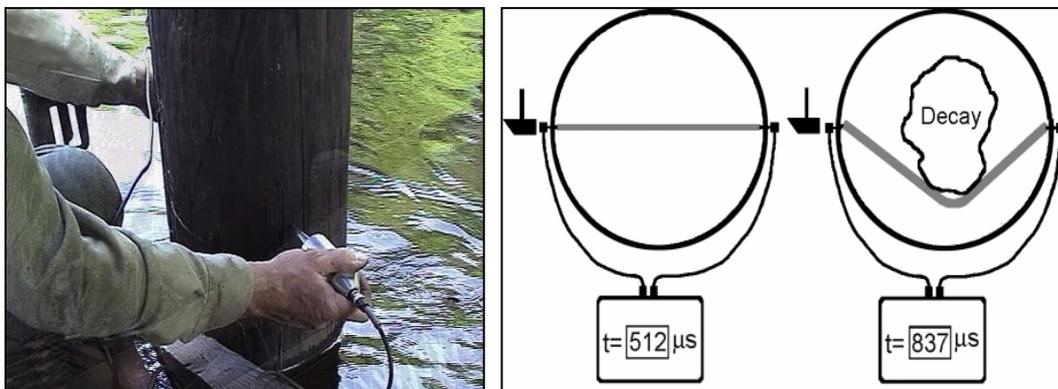
Stress wave transmission times are shortest along the grain (parallel to fiber) and longest across the grain (perpendicular to fiber). For common timber bridge species Douglas fir and southern pine at dry conditions, stress wave transmission time is approximately $200 \mu\text{s}/\text{m}$ ($60 \mu\text{s}/\text{ft}$) parallel to grain, but ranges from 850 to $1000 \mu\text{s}/\text{m}$ (259 to $305 \mu\text{s}/\text{ft}$) in the perpendicular or cross-grain direction. The presence of deterioration from decay can greatly affect stress wave transmission time in wood. Transmission times for decayed wood are much greater than that for nondecayed wood. For example, transmission time for nondegraded Douglas fir is approximately $800 \mu\text{s}/\text{m}$ ($244 \mu\text{s}/\text{ft}$), whereas severely degraded members exhibit values as high as $3,200 \mu\text{s}/\text{m}$ ($975 \mu\text{s}/\text{ft}$) or greater.

Figure 6 – A stress wave timer is used to inspect timber bridge elements to identify the presence of internal decay that is not visible.
