# Investigation of Glulam Girder Bridges Constructed Prior to 1970

## Summary

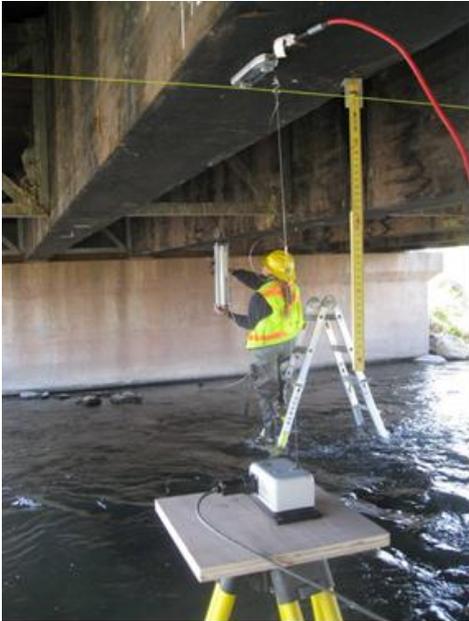
Figure 1. Live load testing data was collected via string potentiometers (deflection) and transducers (strain).

Two groups of glulam girder bridges were investigated in the states of Oregon and Washington during the 2009 and 2010 summer seasons. Static live load testing was conducted at all field bridges. Two different load cases were evaluated for each bridge. Load case 1 had the truck straddling the roadway centreline while its centroid was positioned at midspan. Load case 2 had the truck shifted laterally so that the wheel line was 0.6 m from the curb face. In all cases, data was collected before and after loading to detect residual movements. Supports were also checked to ensure there was no settlement under loading. Midspan deflections were collected with Celesco string potentiometers attached to the bottom side of the beams (Figure 1). Strain measurements were collected with transducers manufactured by Bridge Diagnostics Inc. Strain transducers were mounted on each girder at the midspan-bottom tension zone and at the intermediate support- topside tension zone. The data collection was automatically captured with a Campbell-Scientific CR-10 datalogger unit. In addition, suspended rulers and an optical level were used to collect midspan static deflections of the glulam girders (Figure 2)

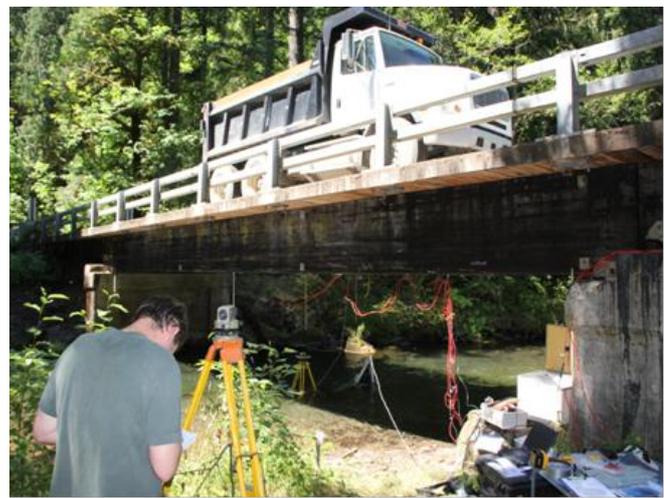
Figure 2. Optical level was also used to collect deflections from calibrated rules suspended from each girder.

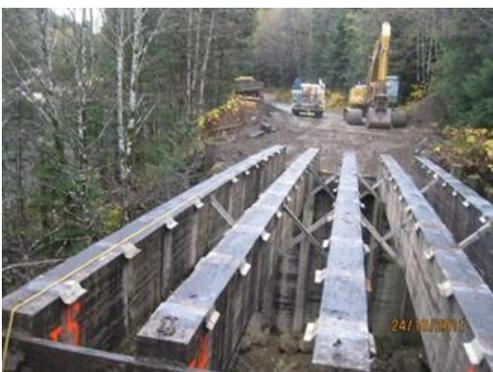
Figure 3. Pre-1970 glulam girders salvaged from site in Alaska.

After the 15.2m (50 ft) long glulam girders were removed from service at the Jenny Creek bridge site near Kake, Alaska (Figure 3), they were transported to the Forest Products Laboratory in Madison, Wisconsin. Several laboratory investigations were conducted in order to reliably determine the residual capacity of these early glulam bridge girders. Visual defects were physically mapped, in addition to extensive scanning using stress wave timing device in a perpendicular to grain orientation (Figure 4). Static load testing was conducted (Figure 5) using 4-point bending arrangement in order to produce a uniform bending moment through the midspan section of the bridge girders. Testing was first completed to measure the modulus of elasticity of each beam. Then loading to ultimate failure was performed over a 10-minute load duration target period.

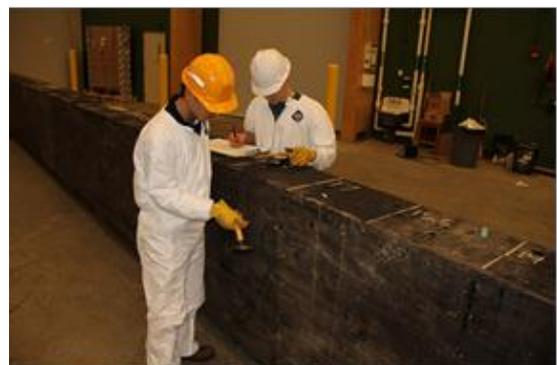
Figure 4. NDE testing is performed in the laboratory to detect internal decay.

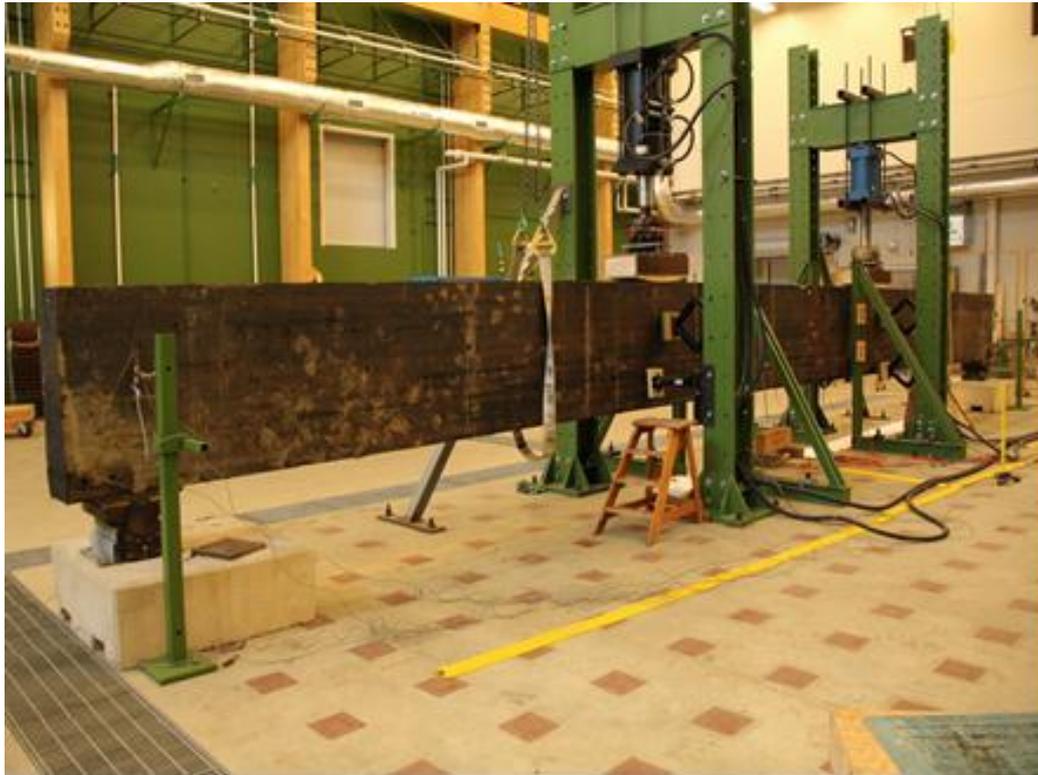
*Figure 5. Static load testing was performed to determine member stiffness and ultimate load capacity of these 60-year-old salvaged glulam girders at the FPL Centennial Research Facility.*

Testing results of four members showed that these pre-1970 manufactured glulam bridge girders had an average modulus of elasticity of 11,652 MPa ( $1.69 \times 10^6$  lb/in.<sup>2</sup>) and failed at an average applied loading of 645 kN (145 Kips). These values are significantly higher than the original design stress level and suggest that the strength reduction factors may be overly conservative in some cases.
