REHABILITATION AND UPGRADING OF A HERITAGE LISTED TIMBER TRUSS BRIDGE

Keith Crews
Professor of Structural
Engineering & Assoc Dean
University of Technology
Sydney,
Australia
keith.crews@uts.edu.au

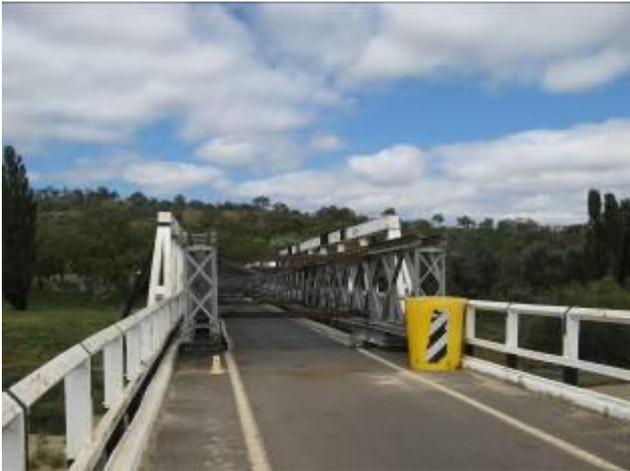
Figure 2 – Bailey Trusses in 2005

Degradation as a result of inadequate maintenance and construction details that trap moisture, has meant that the principal timber truss elements have been periodically replaced throughout the life of the bridge. However, by the turn of the 20th century significant deterioration of the structure eventually caused a loss in capacity of the main truss elements, resulting in installation of Bailey support trusses in 2005 and then finally closure of the bridge in 2006. Subsequently, in response to community support for the original bridge design and recognition of its significance, Roads ACT proposed a \$25m rehabilitation in 2007, involving upgrading of the Allan truss structures rather than the replacement of the bridge.

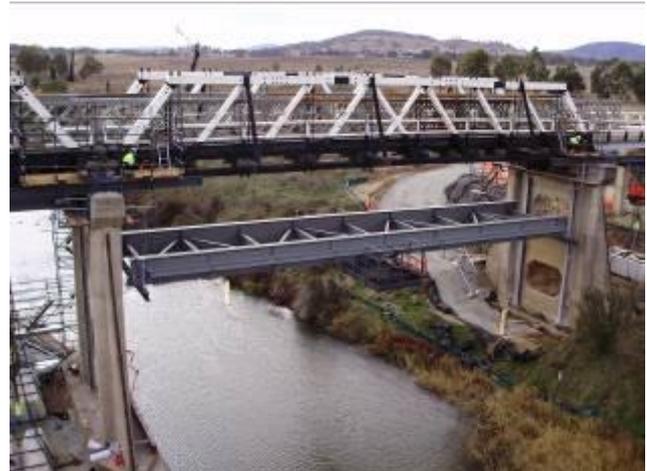
Figure 3 – Temporary support structure 2008

The first stage involved temporarily supporting the deck using steel under-slung girders so as to remove the Bailey and timber trusses, and allow traffic access after nearly two years of closure. The bridge was re-opened with a 5 tonne load limit in August 2008.

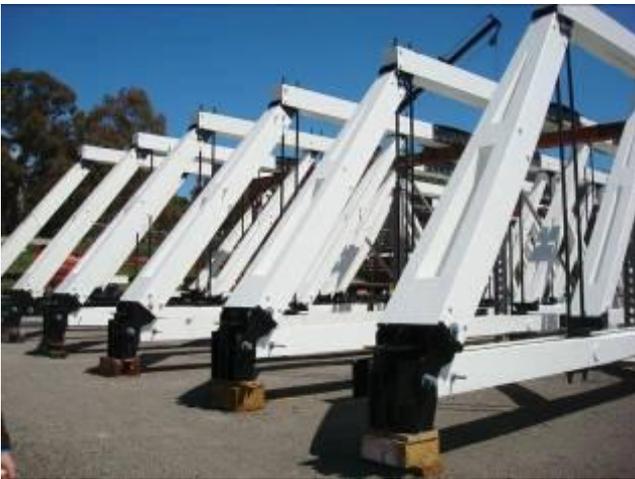
Figure 8 – Truss Assembly on site

A camber of 31mm was designed and built into each truss, since the truss shoes would have been overstressed if the truss was built square and level prior to inducing the camber. A truss assembly pad was designed and built on site to allow assembly of the eight trusses in a narrow line which also enabled the crane to reach all of them from a single set up. Progressive installation of temporary props allowed progressive truss assembly to occur. Temporary truss supports were also installed to prevent the trusses pulling apart during lifting. Planning for truss lift commenced some over 12 months prior to the lift date.

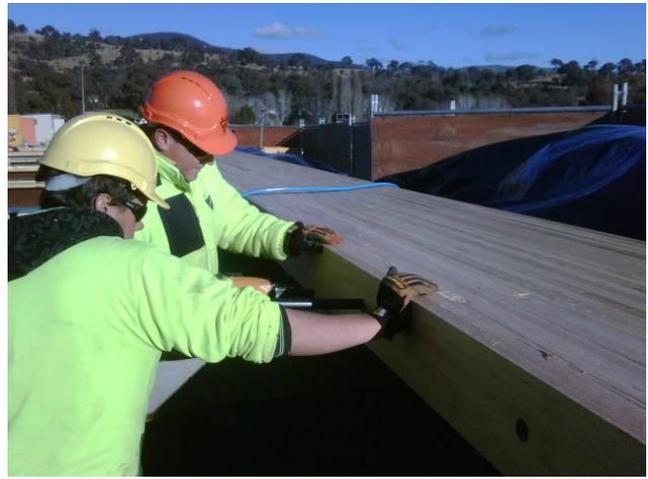
Figure 9 – Assembling the SLT deck on site

The SLT deck was constructed as a monolithic orthotropic plate, 110 metres long, which eliminated the need for joints between the truss - a reduction in joints from a possible five to just one at each end. Deck joints in timber decks tend to be prone to high rates of degradation under traffic loading and this consideration justified the adoption of a full length deck. However, this length of SLT deck is double that of any previously launched in Australia and as such, posed new challenges in the ensuring uniform stressing and correct positioning of the deck. The deck was constructed on site, aligned with the bridge centreline for eventual launching using swivel castor rollers. Careful planning and monitoring of both stress levels and alignment of the deck ensured that it was launched and installed in place successfully.

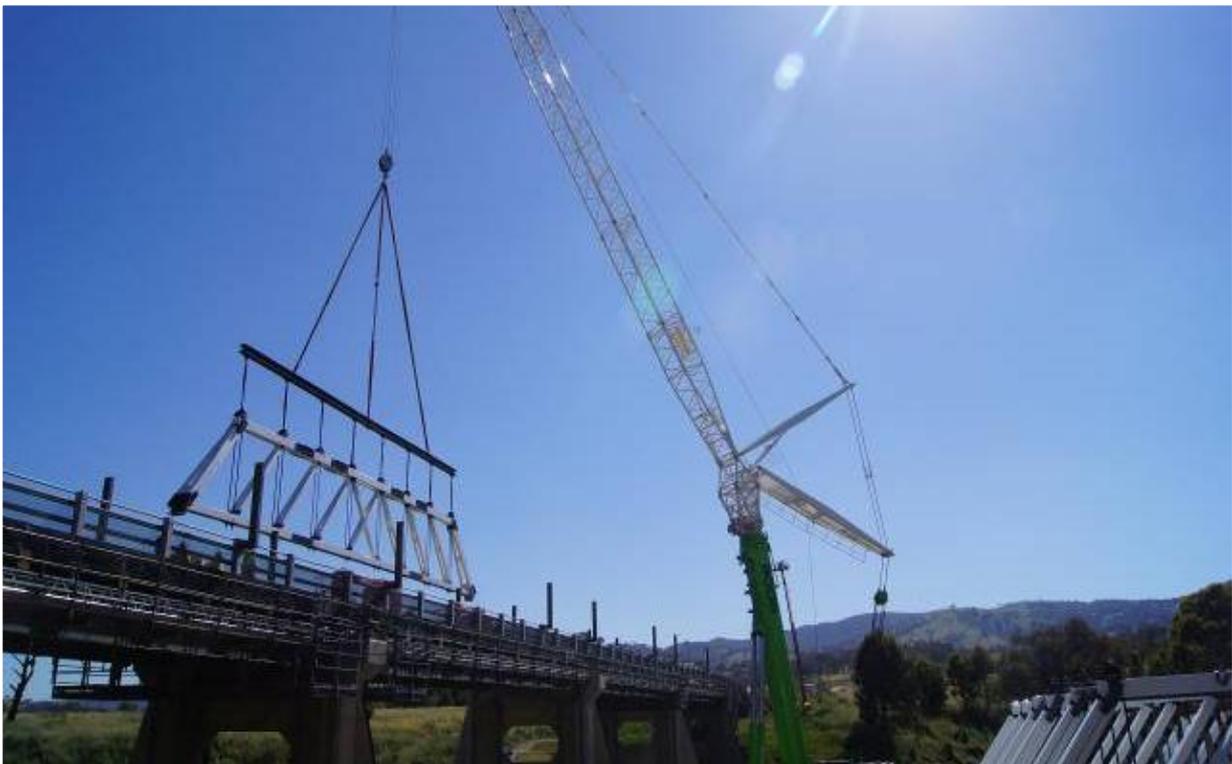
Figure 10 – Truss being lifted into place using a 400t mobile crane

The fully assembled trusses (each 22 tonnes) were installed in three days using a 400 tonne mobile crane with a reach of 45m, allowing installation from a single site set-up adjacent to the Murrumbidgee River. The weight of each timber member was confirmed during truss fabrication to accurately verify the assumed timber density and calculated truss weight. Joint site inspections were undertaken with the crane operator and a specific truss lifting Safe Work Method Statement was developed. Whilst six days were programmed for the installation of the trusses, all eight lifts were completed within three days.

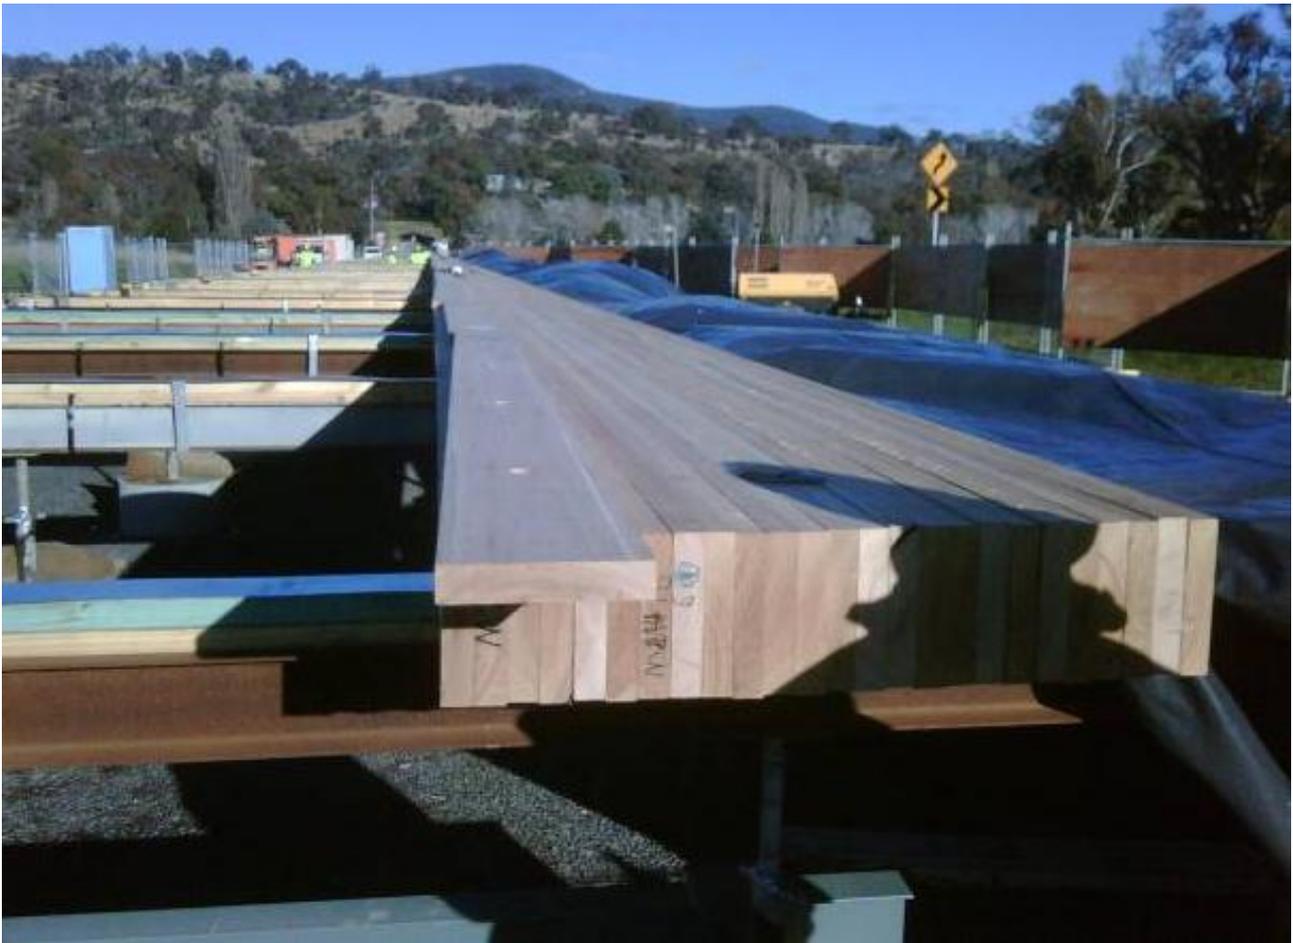
Figure 12 – Construction of the SLT deck showing laminate lay-up

1. the stressing elements had to “fit” within the truss geometry to ensure appropriate access for stressing hardware in order for re-stressing to occur
2. the deck needed to utilise readily available standard sized timber
3. The butt joint pattern was not to exceed one joint in every four laminates across the deck width (1 in 4 pattern).

The deck was designed as a continuous plate in conformity with the new RTA standard [4] using kiln dried F27 blackbutt, with design properties of $f'_b = 80$ MPa and $MOE = 18500$ MPa. Construction consisted of 3,500 individual laminates which were fabricated (docking and drilling of holes) off site, then sorted with each bundle delivered to site in a planned sequence to optimise construction. Once on site the workmen laid out the laminates in the order they were to be nailed, saving sorting time on site and reducing exposure of laminates to wet weather. A specifically designed SLT support bed and work area was constructed, including key blocks along the centreline of the deck to provide lateral stability during stressing. The SLT deck was built 200mm longer than specified to allow it to be cut to the final “actual” length.

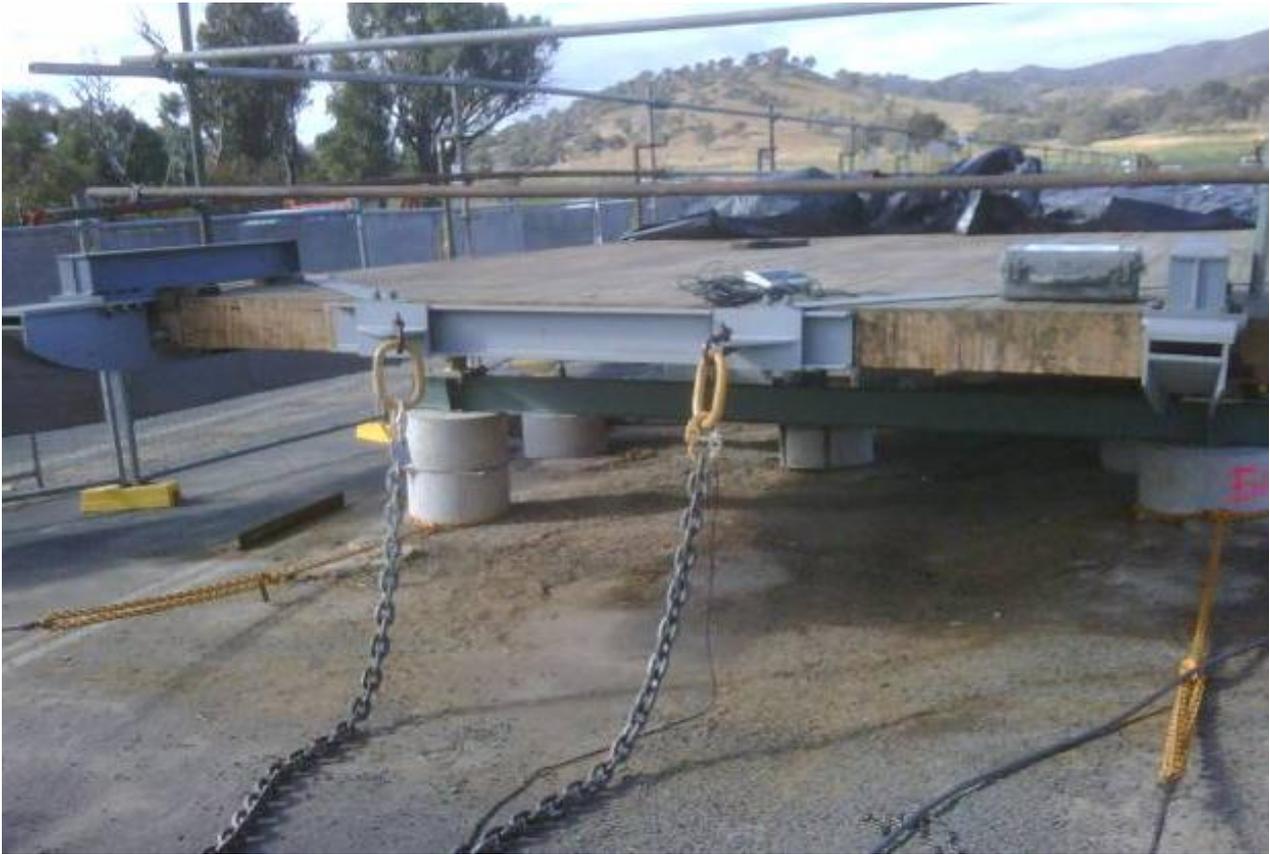
Figure 13 – SLT deck Launching Nose

Launching of the SLT deck was carried out in 3 days in early May 2011 using a 24 tonne truck with an 8 tonne winch pulling from the front end, with another 24 tonne truck and winch restraining the deck from the rear end. The winch steel wire rope was attached to a specially designed and fabricated launching nose and pulling frame. The actual maximum pulling force exerted on the 100 tonne deck was 2 tonnes. The deck was then winched along on swivel castors which were guided by a channel fixed to the underside of the deck to keep it in line.
