## Goodpasture Covered Bridge Rehabilitation

The Goodpasture Covered Bridge, crossing the McKenzie River, is a 72.5 m (238-foot) five-span timber structure that provides lifeline access to a large community. The main span is a 50.3 m (165-foot) covered heavy timber Howe truss. The truss chords have three leaves, each made of segments spliced together. Eight of the sixteen bottom chord splices were broken, and the truss sagged 100 mm at mid-span. Site constraints dictated that all repair work be performed under traffic and without temporary support beneath the bridge. The solution was a post-tensioning system for the bottom chords to provide an alternate load path. To lift the center of the bridge to the proper camber without support from below, a pair of tube-steel trusses were constructed inside the house to bear the loads. The bridge was lifted 200 mm at mid-span to achieve 100 mm of positive camber, and held by the steel trusses while the hanger rods were tightened and post-tensioning system installed.

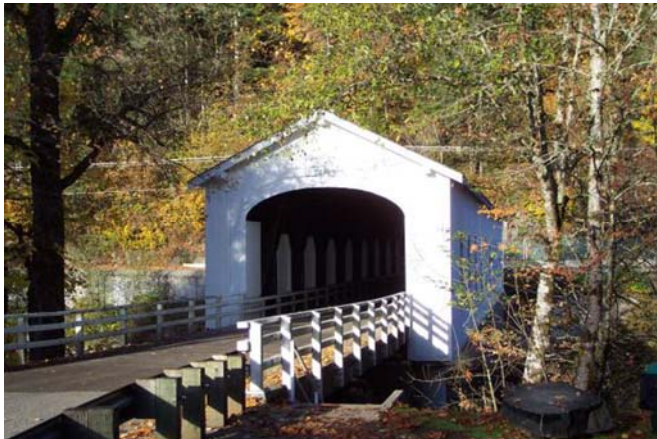
Fig. 1 Goodpasture Covered Bridge

Each of the inner and outer leaves of the bottom chords of both trusses are four-piece members. Each of the middle leaves is made from three pieces. Of the sixteen resulting bottom chord splices, eight are broken and were repaired with heavy steel tie-rod and plate assemblies lag-screwed to the timber chord members, first in the 1970s and again in the 1980s. The repairs were only marginally effective. When OBEC Consulting Engineers inspected the bridge in 2010 there were gaps between the ends of timber members at all of the repaired splices, some over 13 mm wide, and the bridge sagged over 100 mm at mid-span.
