# Chambers Covered Railroad Bridge Salvage and Rehabilitation

## Summary

The Chambers Covered Bridge was built in 1925 and is the last remaining covered railroad bridge in Oregon, possibly the only one west of the Mississippi. Therefore, its rehabilitation was critical to historic preservation efforts of the country's remaining covered rail bridges. Before rehabilitation, the 27.4 m (90-foot) long timber structure was in danger of collapse after decades of neglect. In 2010 a windstorm threatened to destroy the bridge. This unique, single-span, four-leaf Howe truss structure was dismantled and rebuilt using almost all the original iron and hardware, and 25 percent of the original timber. The bridge was reconstructed on dry ground and launched onto the existing concrete piers. The rehabilitated Chambers Covered Bridge now serves as a landmark pedestrian and bicycle crossing that provides safe access across the Coast Fork of the Willamette River. Locomotive-inspired artwork within and around the structure evoke the bridge's history.

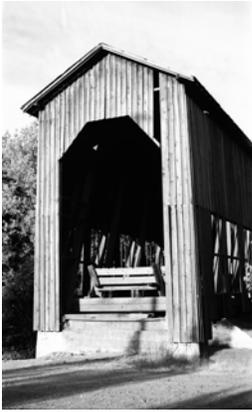
*Fig. 2 Bridge, 1975*

remained abandoned at the edge of the old mill site, suffering the ravages of neglect, weather, and vandalism.

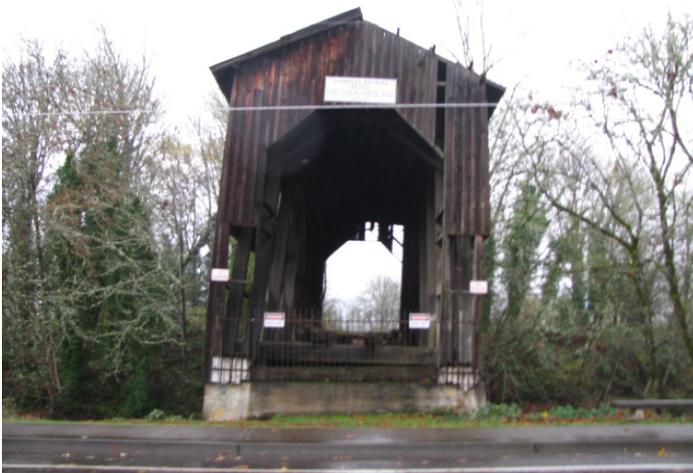
*Fig. 3 Bridge in 2008*

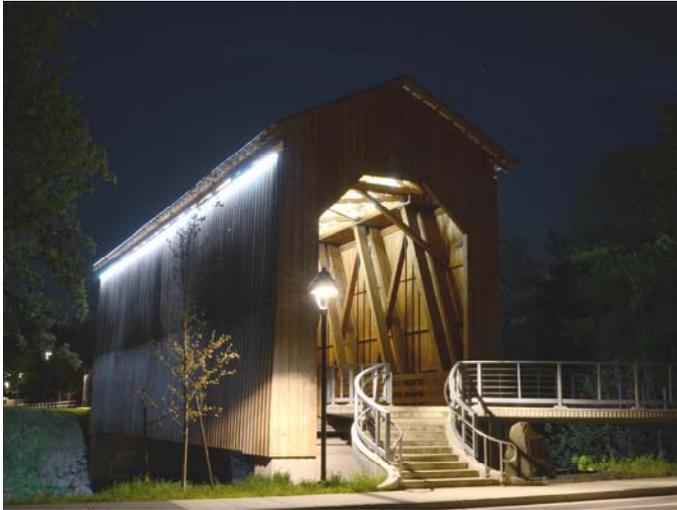
Fig. 8 Bridge lighting at night

High-efficiency electric lights were added, discretely concealed above the top chords of the trusses and controlled by exterior light sensors. They are aimed upward and reflect off the underside of the metal roofing, providing pleasant, indirect interior lighting after dark. There are also LED strip lights tucked under the eaves that softly wash the sides of the covered bridge, making it visible at night to passers-by.

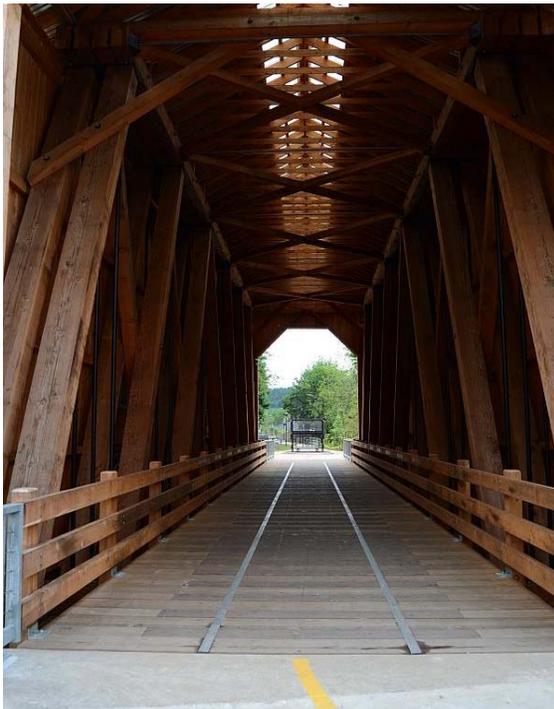
Fig. 9 Interior with "tracks"

To evoke images of the railroad, alternate deck planks are stained to resemble ties, and two continuous steel strips are imbedded into the wood spaced at standard track gauge. Artists from Sea Reach, Ltd. created two full-scale sculptures of one of the locomotives that used to traverse the bridge. One of the

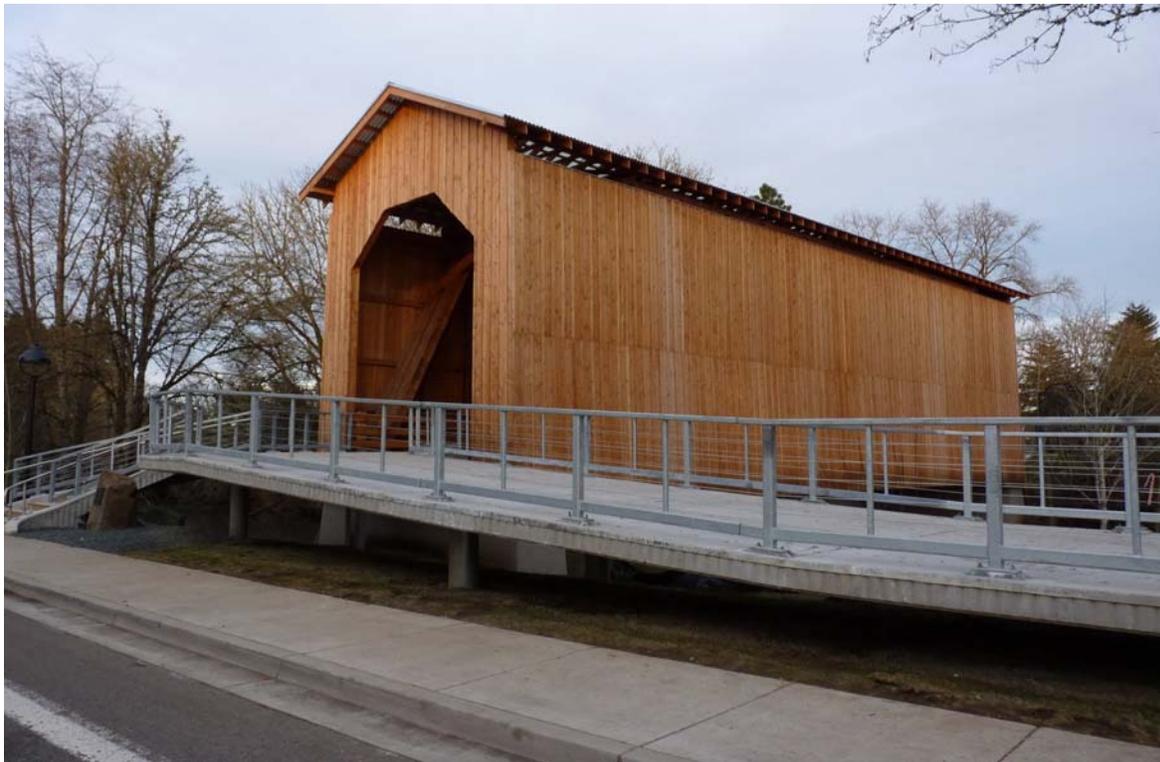
*Fig. 10 Bridge entrance after rehabilitation*
